Debris/Ice/TPS Assessment and Integrated Photographic Analysis of Shuttle Mission STS-91

**DEBRIS/ICE/TPS ASSESSMENT
AND
INTEGRATED PHOTOGRAPHIC ANALYSIS
OF
SHUTTLE MISSION STS-91**

2 June 1998

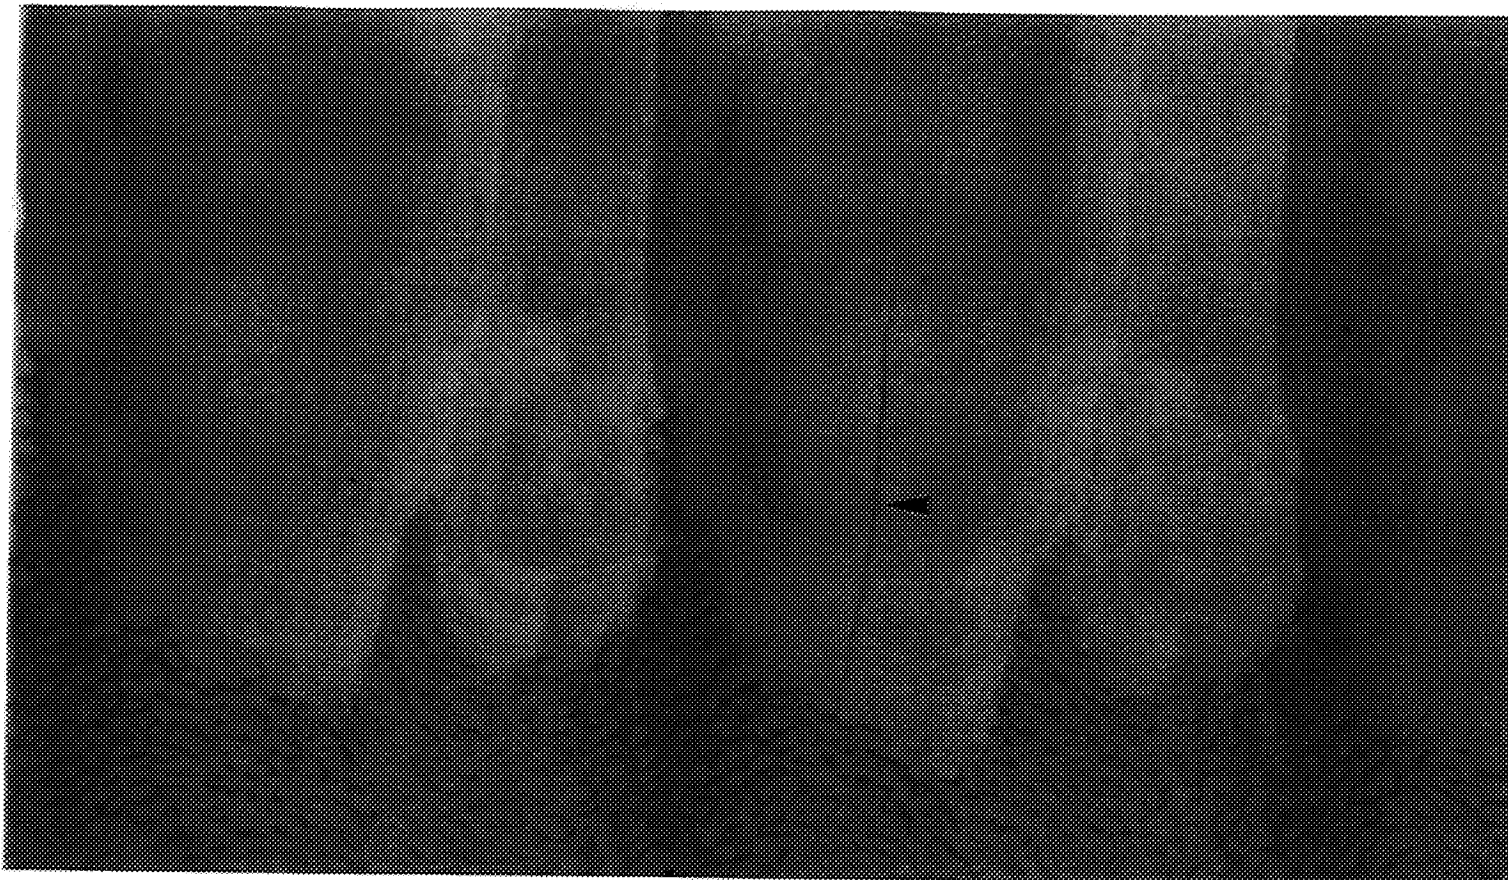
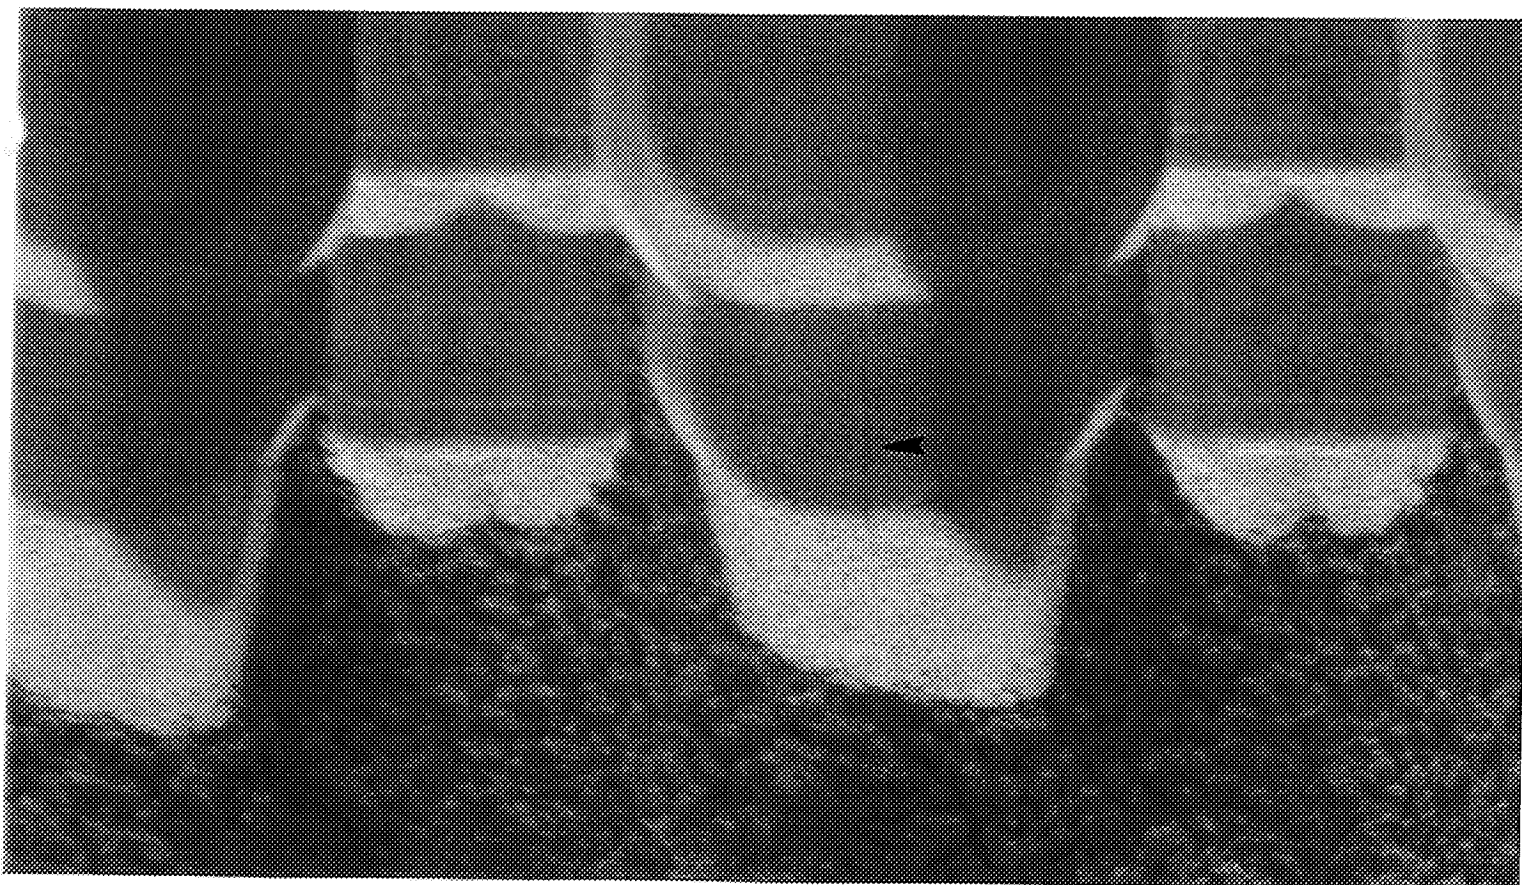
Photo 25: Cracks in Intertank Foam

All of the cracks were no greater than 1/16 inch wide with no visible offset or ice/frost formation and were acceptable for flight per the NSTS-08303 criteria and tanking test IPR rationale.

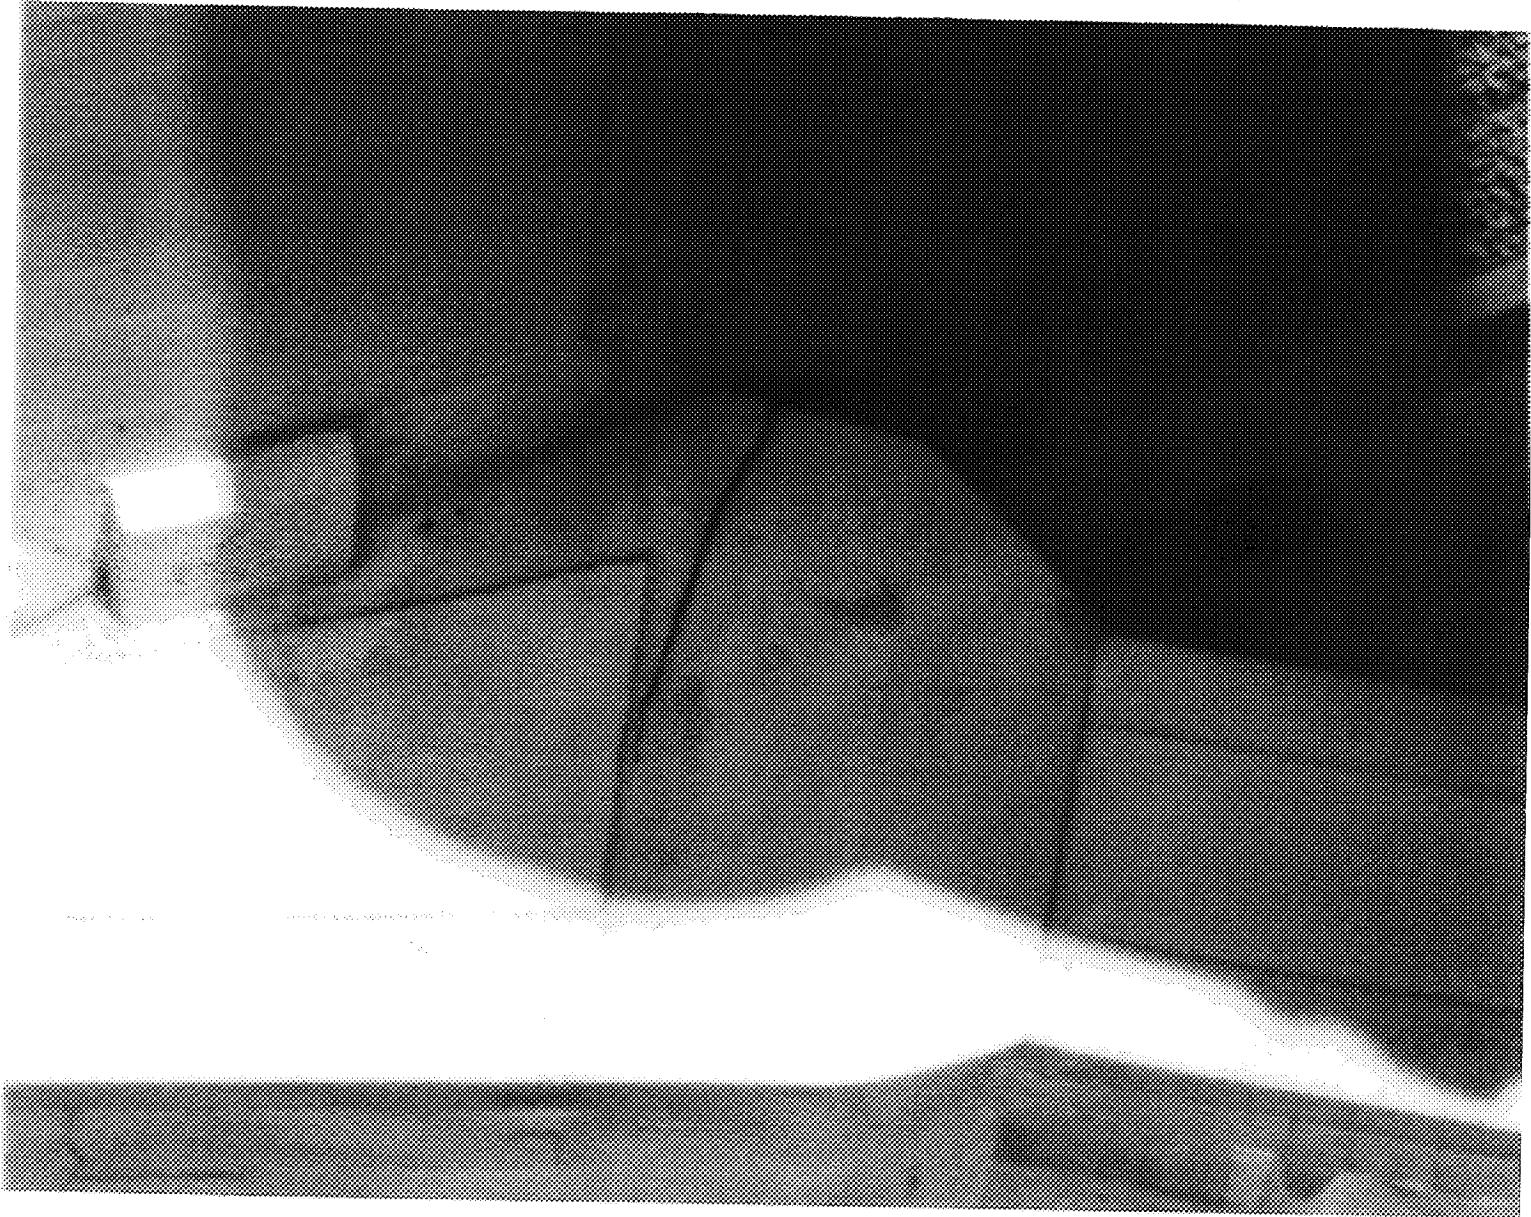
Photo 26: -Y Vertical Strut

A 12-inch long by 3/8-inch wide stress relief crack had formed, as expected, on the -Y vertical strut forward facing TPS. There was no ice/frost present and no offset. The condition was acceptable for launch per the NSTS-08303 criteria.

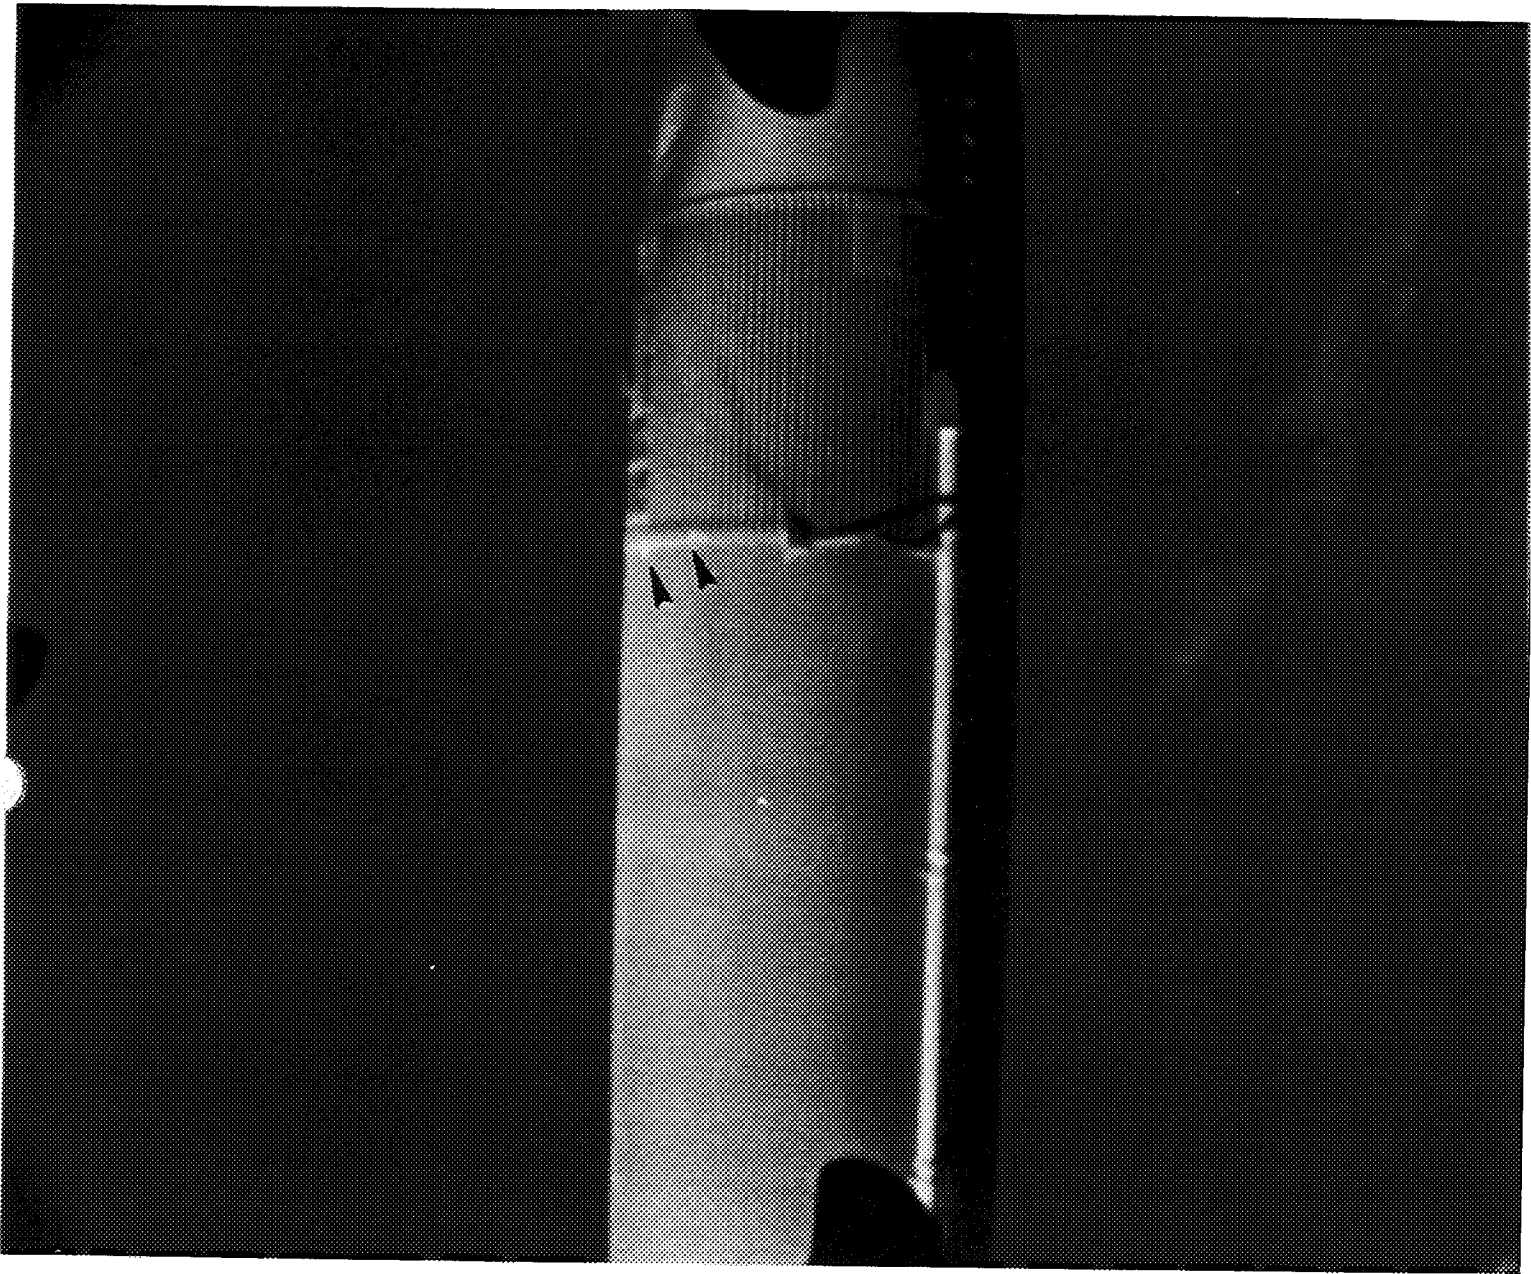
Photo 32: ET After Separation from Orbiter

No divots were visible in the LO2 and LH2 tank acreage. Twenty to twenty-five light colored spots were detected in the -Y thrust panel acreage in an area bordered by the LO2 and LH2 tank-to-intertank flange closeouts and from the thrust panel-to-intertank splice to the tank curving out of view in the -Y direction. These light colored spots are most likely small, shallow divots, most of which are in the areas between the ring frames. However, some of the possible divots could be seen on the forward ring frame. Two divots, 4-6 inches in diameter, were present in the flange closeout -Y+Z quadrant. A much larger 10-inch long divot was also present in the flange closeout near the -Y thrust panel (arrows).

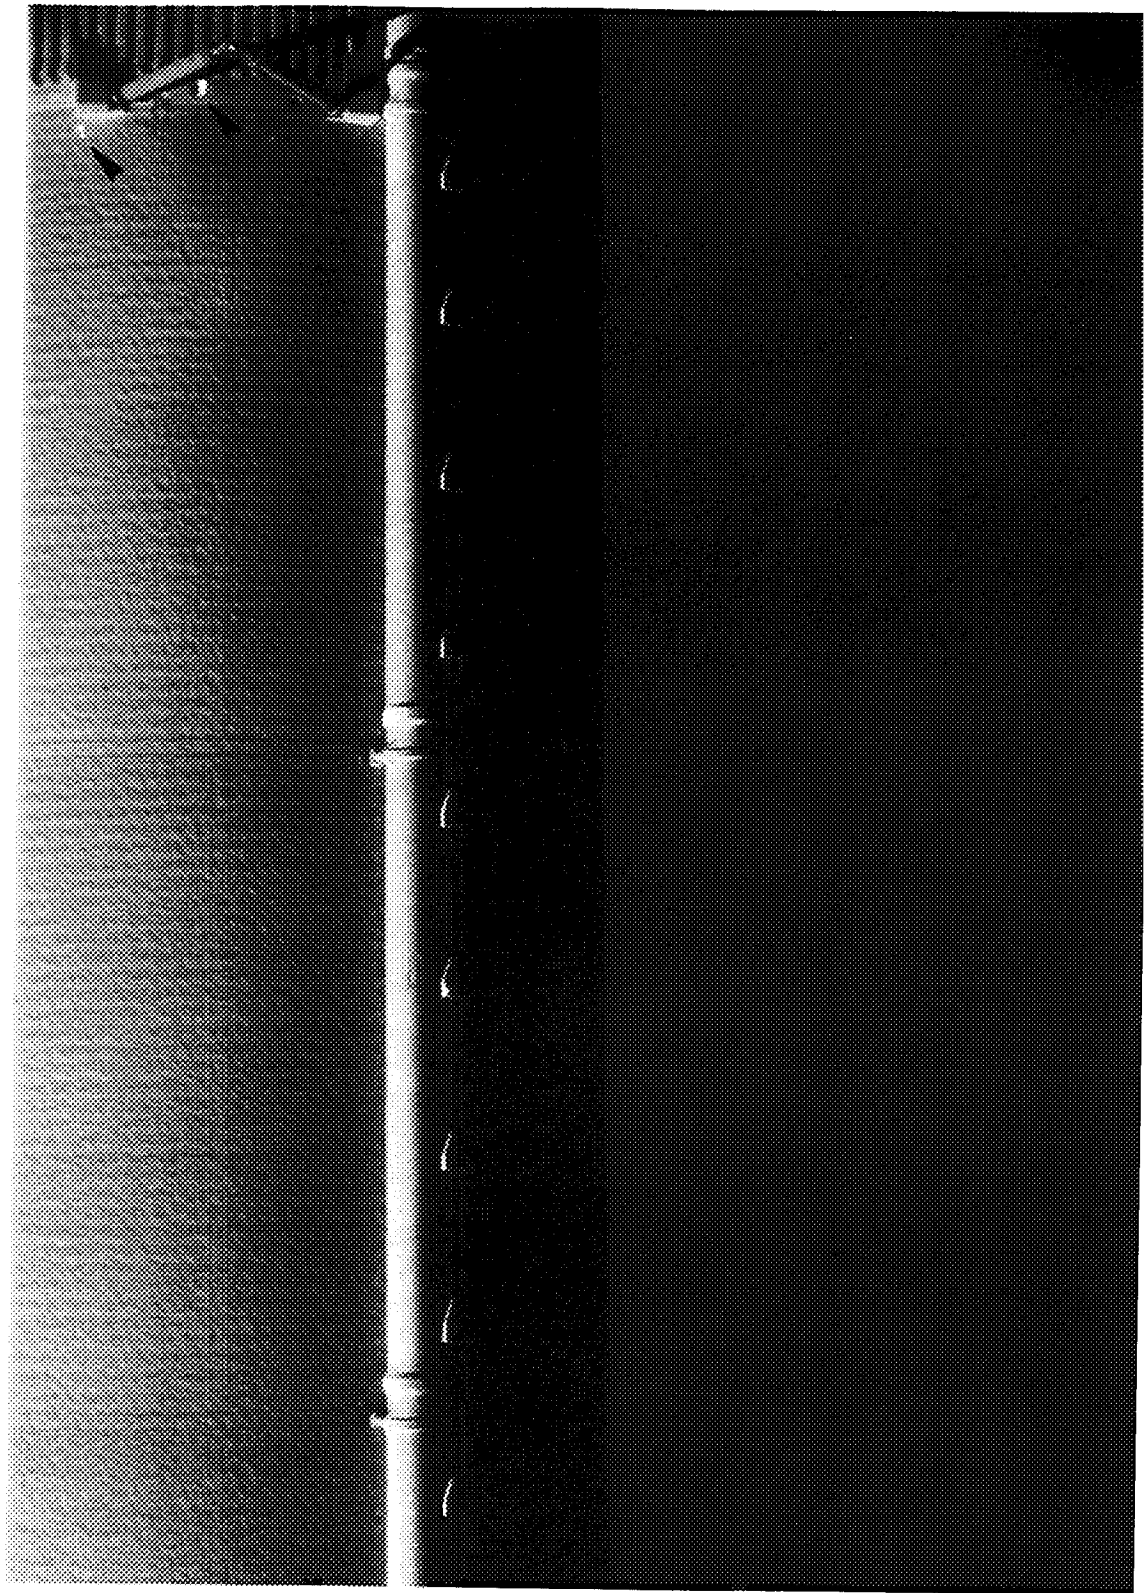
Photo 34: LH2 Tank Flange Closeout

The jack pad standoff closeouts were intact. A 6-inch diameter divot was visible between the bipods near centerline in the LH2 tank-to-intertank flange closeout. The divot may be associated with a repaired area documented in the pre-launch photography. Shadow, but no substrate, was visible in this divot. A divot just aft of the -Y bipod spindle housing closeout appears to be related to a previous repair documented in the pre-launch photography at the same location.

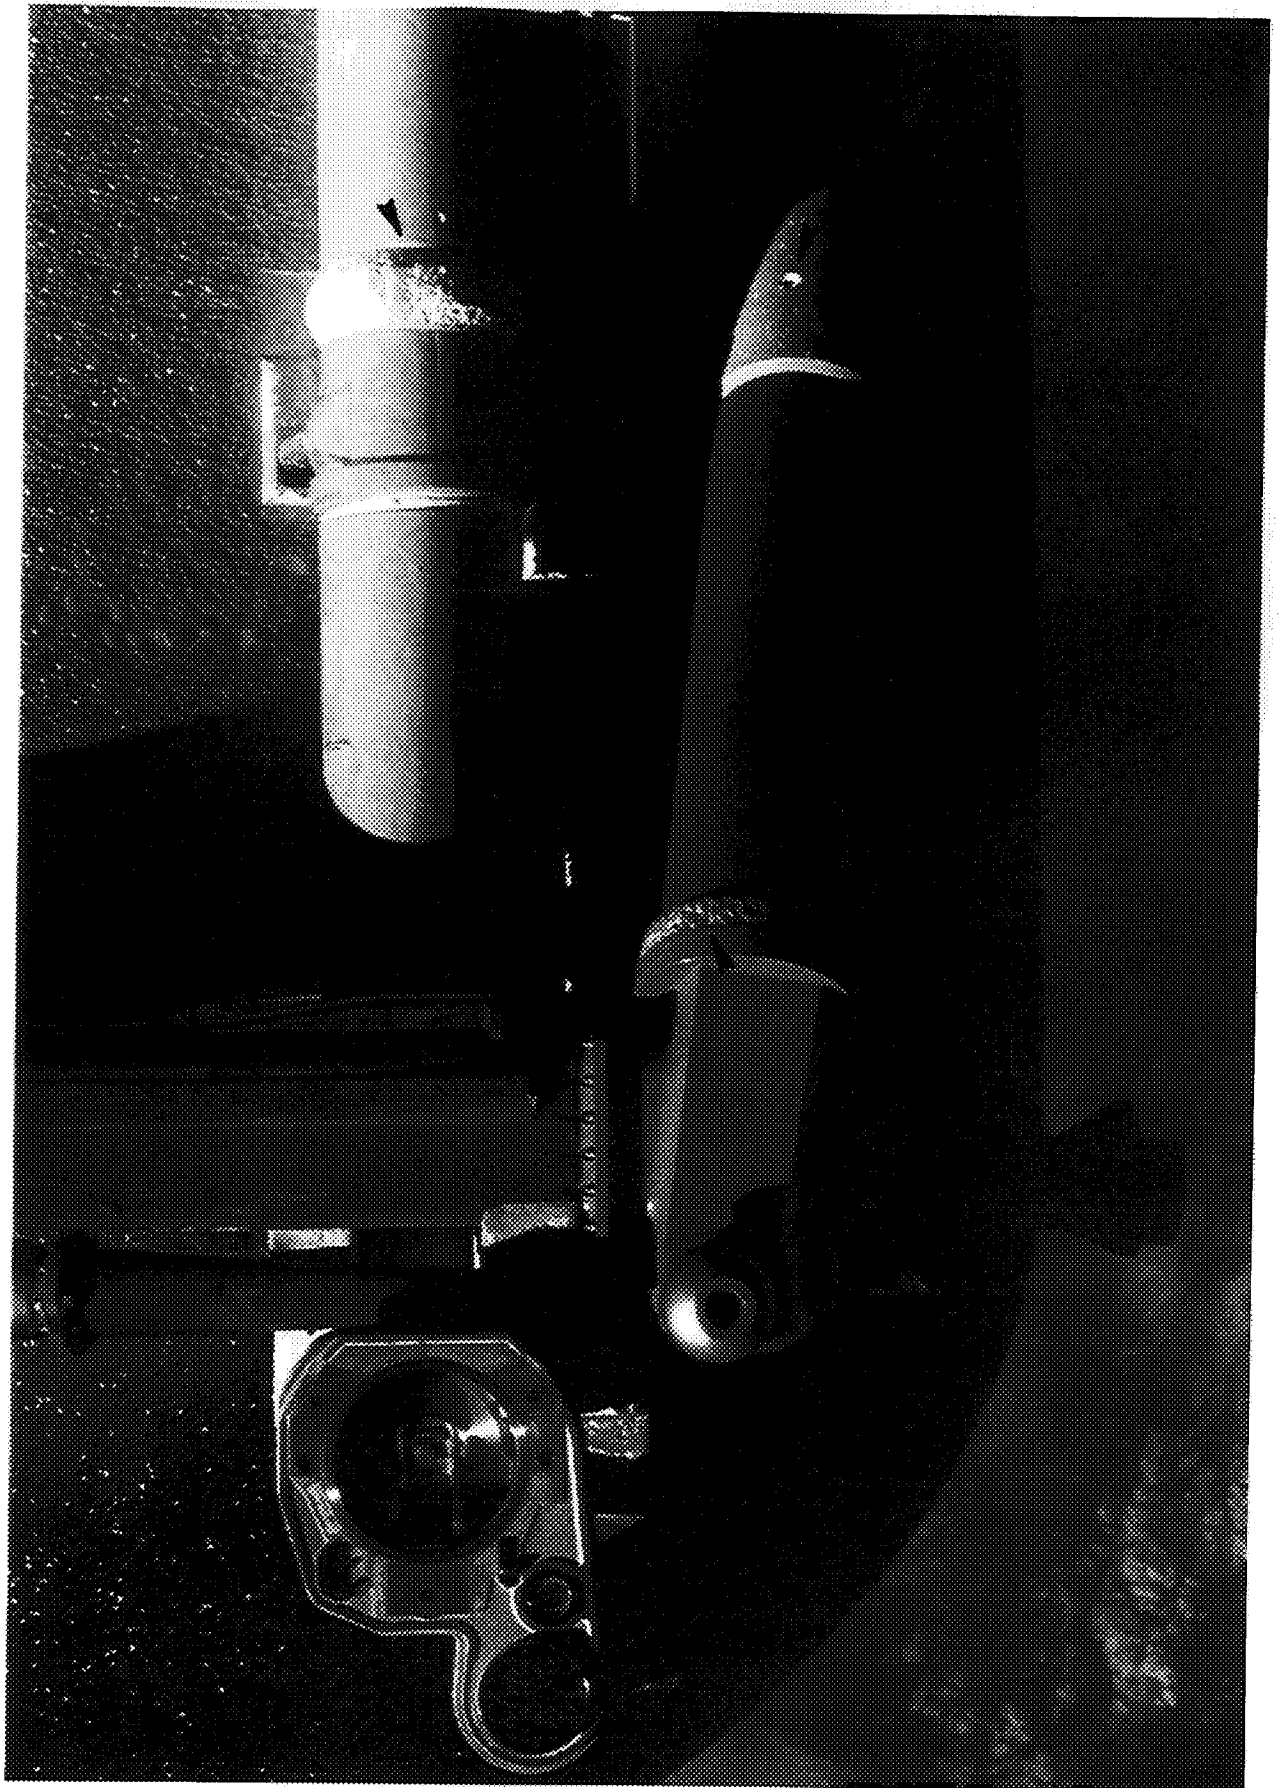
Photo 35: ET LO2 ET/ORB Umbilical

The LO2 ET/ORB umbilical cable tray exhibited typical erosion and divoting. The umbilical itself was undamaged. A 2-inch diameter divot was visible in the +Y thrust strut TPS. Note typical erosion of foam from the LO2 feedline and thrust strut flange closeouts.

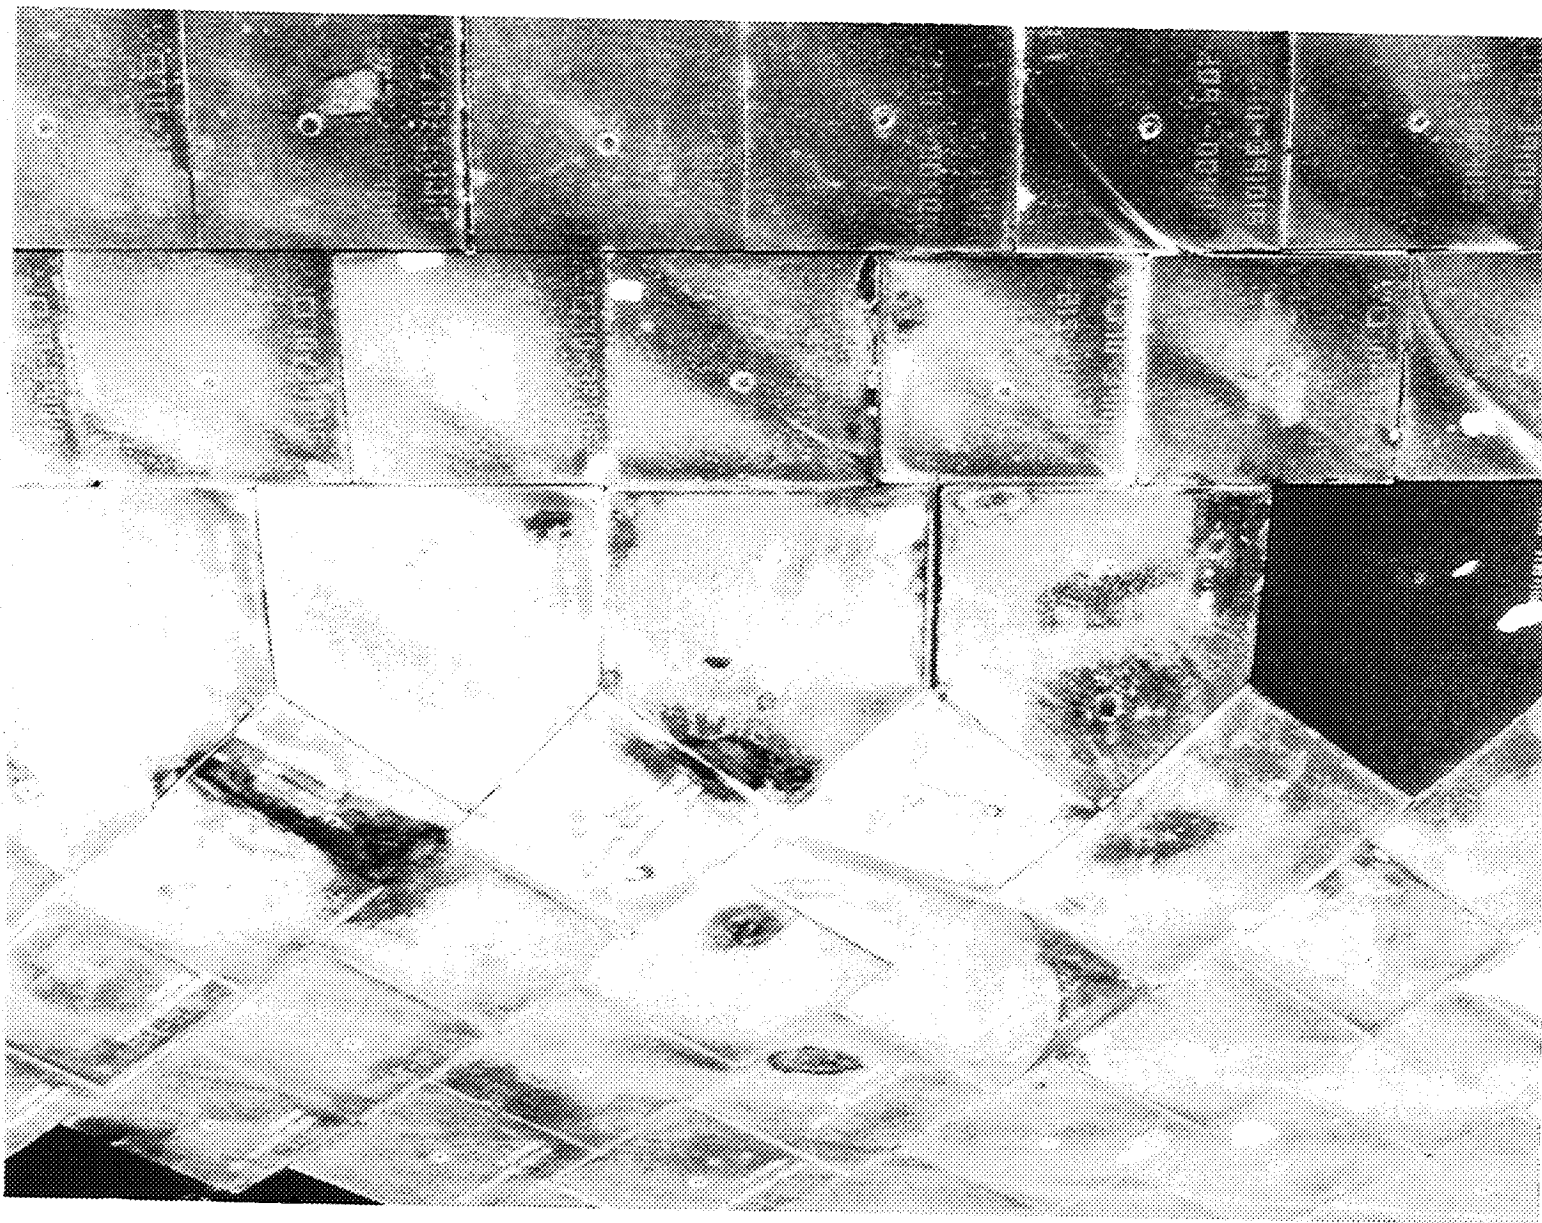
Photo 44: Lower Surface Tile Damage

The largest lower surface tile damage site forward of the main landing gear wheel wells was located on the left chine and measured 3-inches long by 1.25-inches wide by 0.25-inches deep. The deepest lower surface tile damage site of 0.5-inches was located on the right chine.

The Orbiter lower surface sustained 145 total hits, of which 45 had a major dimension of 1-inch or larger. Most of this damage was concentrated aft of the nose to the main landing gear wheel wells on both left and right chines. Virtually no damage occurred on the Orbiter centerline.

The Space Shuttle Program continues to work an IFA to prevent loss of foam from the ET thrust panels and preclude further damage to Orbiter tiles.

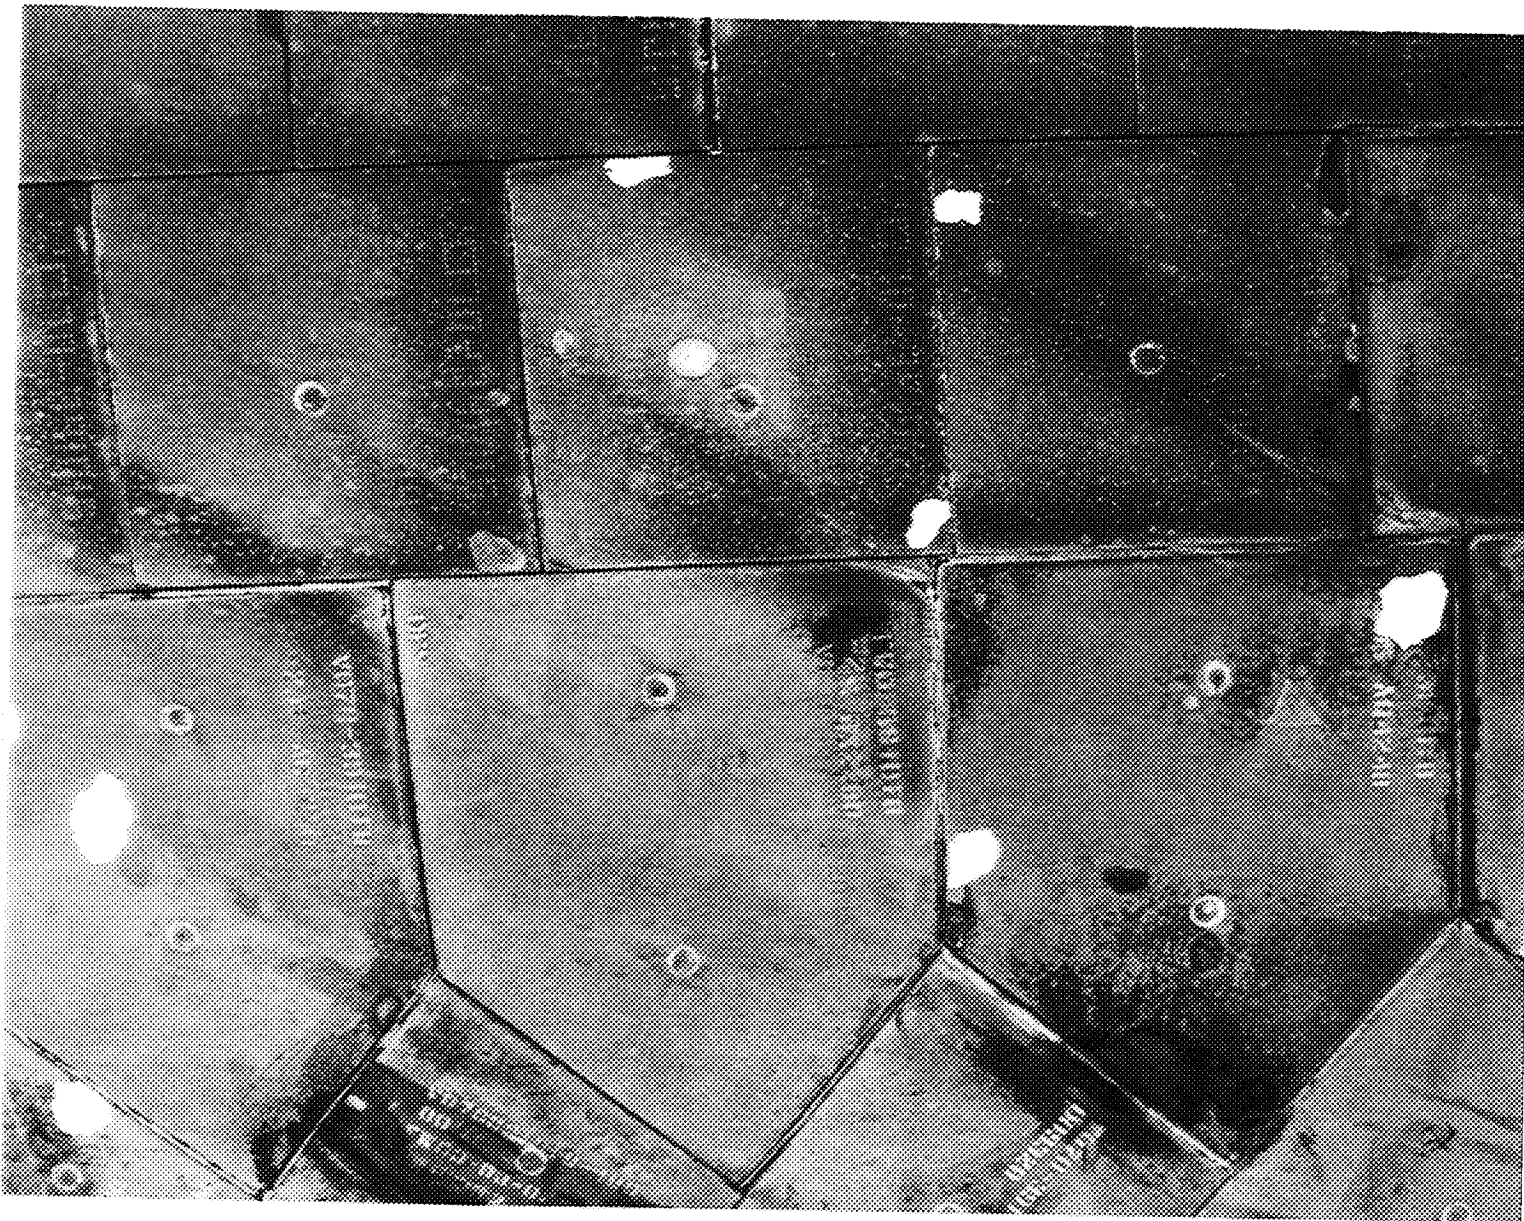
Photo 45: Lower Surface Tile Damage

These damage sites follow the same location/damage pattern documented on STS-86, STS-87, STS-89, and STS-90, though it should also be noted that this was the first flight of the new Super Light Weight Tank. The average size and quantity of damage sites were greater than the favorable trend established on STS-89 and STS-90:

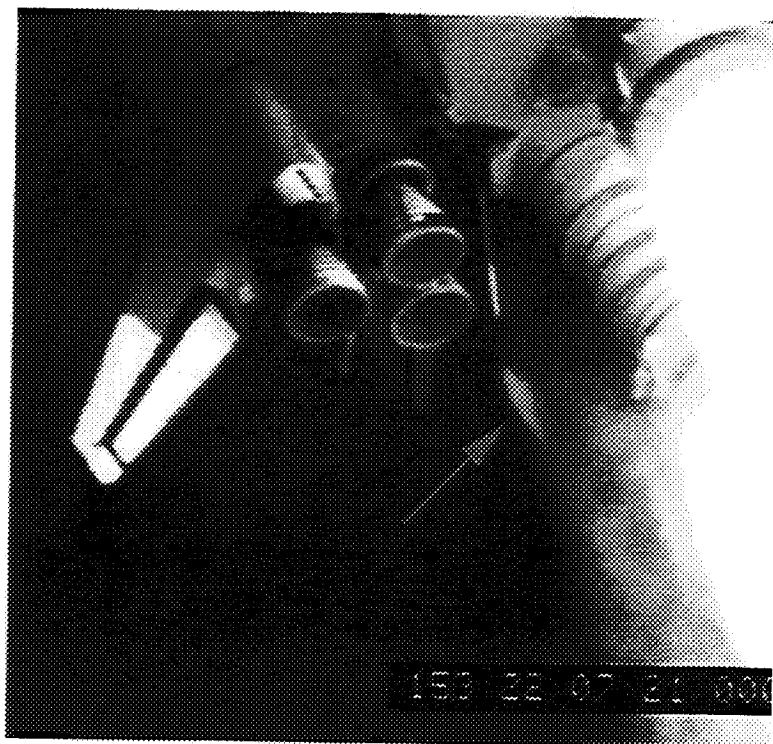
Figure 2.4 Flare in SSME Exhaust Plume During Ascent

A white-colored flash (possibly debris induced) was seen in the SSME exhaust plume during ascent at 22:06:41.731 UTC (E52, E222).
